**Proposed change of the approved bridge and
erosion control structure along the eastern edge of
the channel adjacent to BUCO, City of Mbombela,
Mpumalanga Province**

Draft Environmental Authorisation Amendment Report

26 May 2022

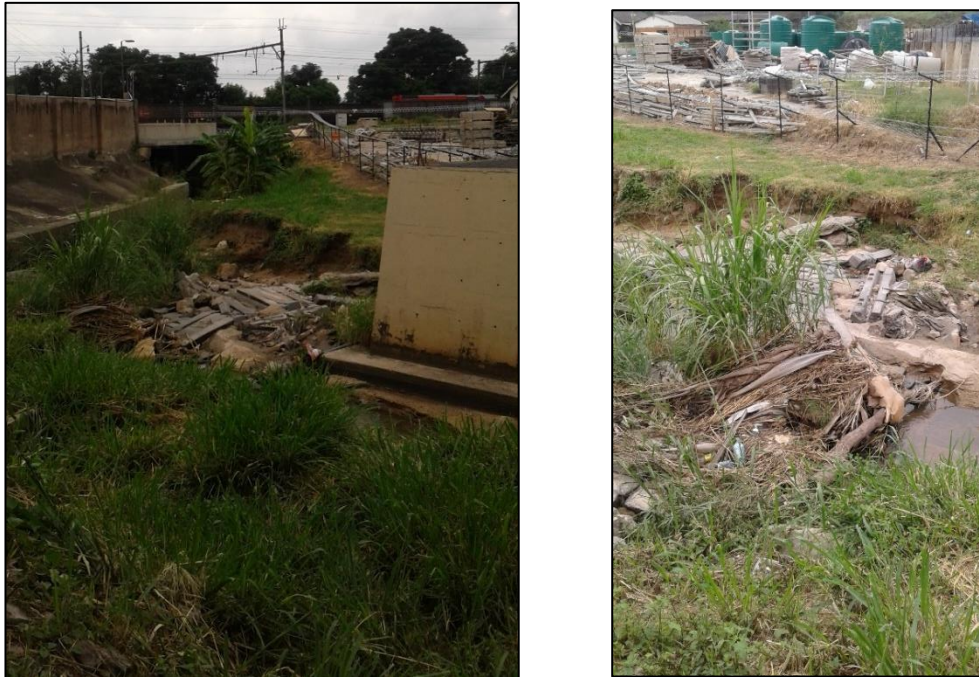
The site is located within an industrial area, with warehouse-type industries occurring all around the site and a railway line passing the northern boundary of the site in an east-west direction. Thus, the original natural ecological characteristics of the site have been completely transformed. The ecological integrity assessment indicated that the watercourse has been “Critically Modified” in accordance with the Habitat Integrity Assessment conducted. The natural habitat and biota have been lost completely and a critical and irreversible loss of ecosystem functioning has occurred. Due to the nature of the surrounding landscape transformation, the modification and removal of habitat and the existing disturbance regime adjacent to the stream, the aquatic system has no biodiversity value and is of low ecological importance and sensitivity.

FIGURE 3: PHOTOS INDICATING THE CURRENT ECOLOGICAL CONDITION OF THE PROPOSED SITE
